SAVEC Facility, RFP 25-01: Site 12

October 20, 2022

Subject: Bristol Bay Task 2 Public Facilities Master Plan Geotechnical Site Assessment - rev1

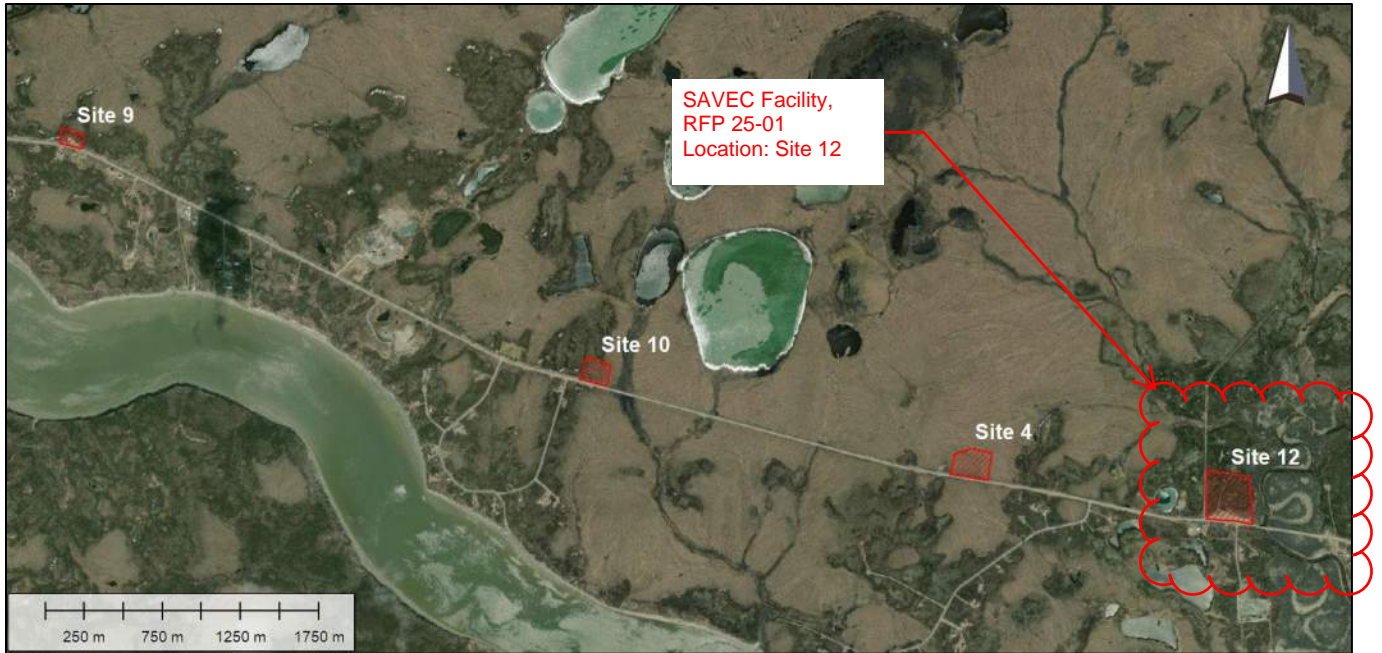
Figure 2. Map overview of site 9, 10, 4 and 12.

Between September 8 and 9, 2022, PND and Bristol Bay Borough, advanced 13 test pits (TPs) at four locations (Figure 2). Test pits at Section 9 and three TPs at Section 12 (TP12-01, -02, and -04) were excavated using a Hitachi 225 backhoe excavator with a 4-foot-wide bucket. Due to mechanical issues, the TPs at Section 4, Section 10, and two TPs from Section 12 (TP12-03 and TP12-05) were advanced by a Bobcat E35 with a 2-foot-wide bucket. During the investigation, grab samples (GR) were collected where a visual change occurred in the soil profile. The recovered samples were field-classified following the ASTM D2488 Visual Manual Procedure and ASTM D4083 Frozen Soil Classification. Graticular coordinates (surveyed with hand-held GPS) and depth of the test pits are shown in Table 1. Aerial maps with as-built test pit locations at each site are shown in Appendix A.

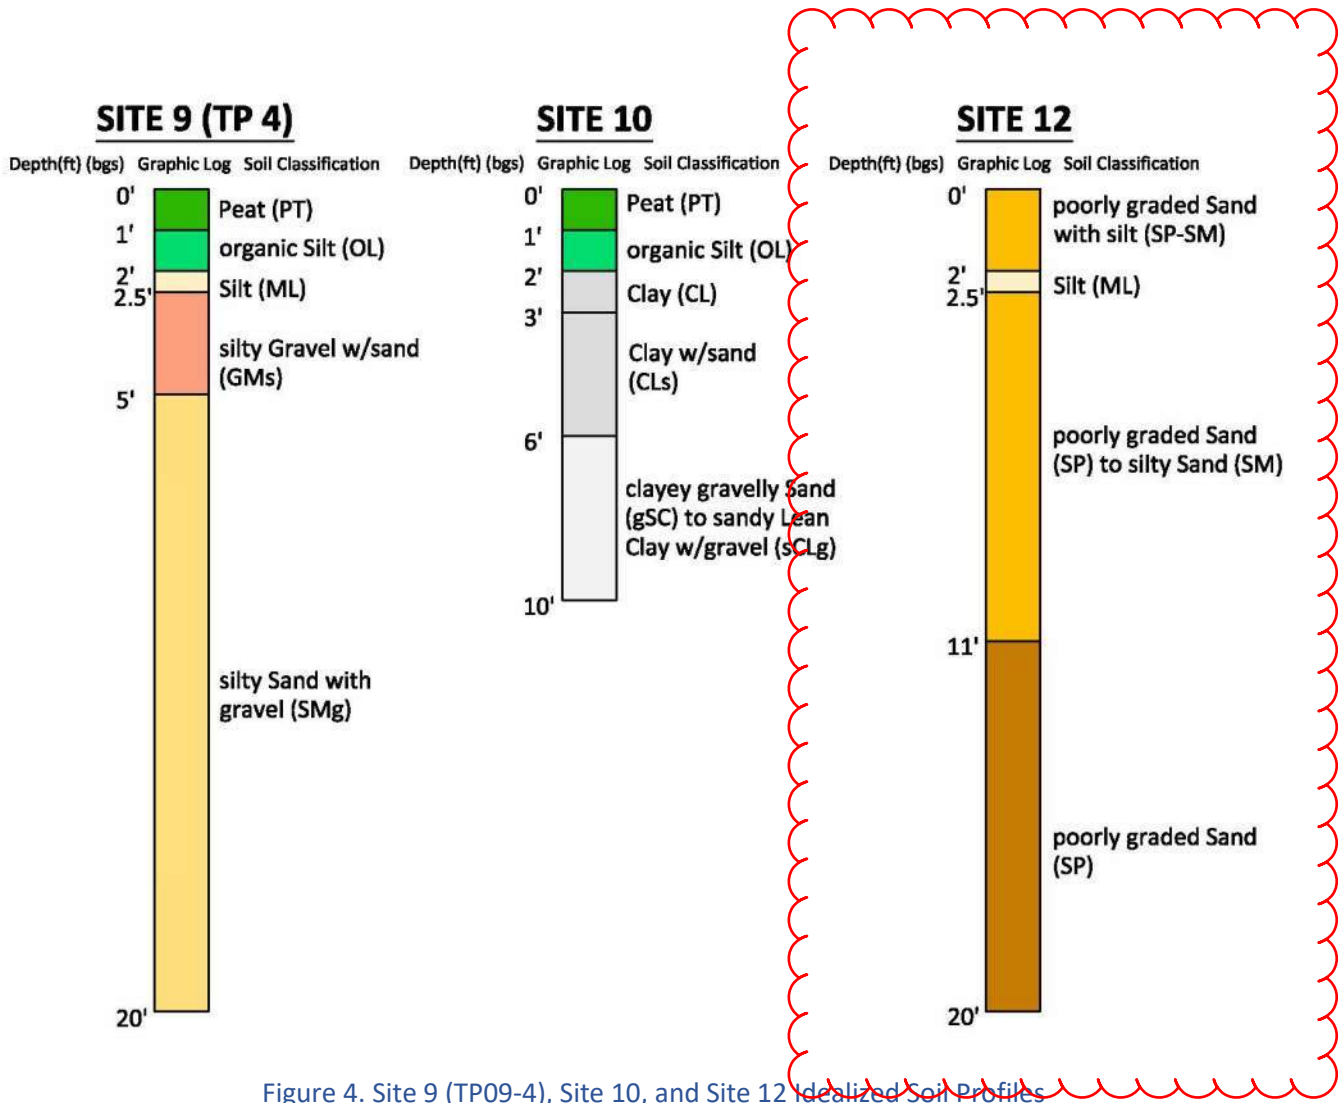
Figure 4. Site 9 (TP09-4), Site 10, and Site 12 Idealized Soil Profiles

- (0-1 ft) Peat (PT)
- (1-2 ft) organic Silt (OL)
- (2-2.5 ft) Silt (ML)
- (2.5-5 ft) silty Gravel with sand (GMs)
- (5-20 ft) silty Sand with gravel (SMg)

- (0-1 ft) Peat (PT)
- (1-2 ft) organic Silt (OL)
- (2-3 ft) Clay (CL)
- (3-6 ft) Clay with sand (CLs)
- (6-10 ft) clayey gravelly Sand (gSC) to sandy Lean Clay w/gravel (sCLg)

- (0-2 ft) poorly graded Sand with silt (SP-SM)
- (2-2.5 ft) Silt (ML)
- (2.5-11 ft) poorly graded Sand (SP) to silty Sand (SM)
- (11-20 ft) poorly graded Sand (SP)

This section summarizes the surface and subsurface characterization of the four sites investigated. The soil and ice characterizations are based on PND field logging observations - Standard Guide for Field Logging of Subsurface Explorations of Soil and Rock (*ASTM D5434-03*) and Standard Practice for Description of Frozen Soils (Visual-Manual Procedure) (*ASTM D4083-07*). See Figure 3 for a visual graphic of soil stratigraphy for Site 4 and Site 9 (TP09-01 and -03) and Figure 4 for Sites 9 (TP09-04), 10, and 12.

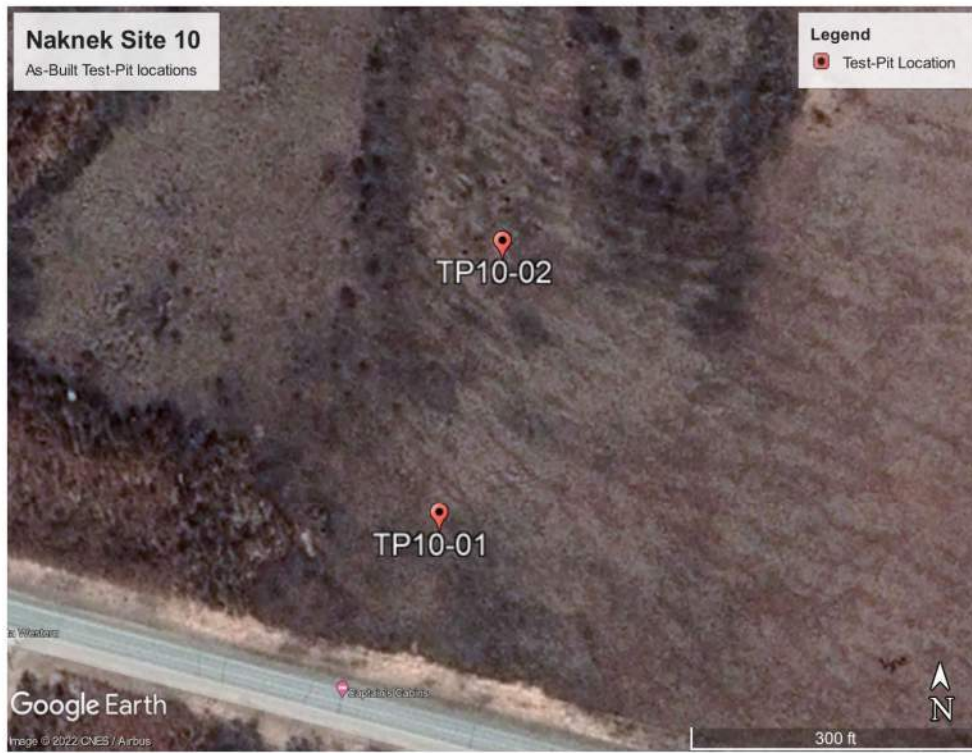
Figure A-3. Site 10 Aerial Map

Site 10 was located 0.3 miles east of the local cemetery. Two test-pits were excavated at Site 10, TP10-01 and TP10-02, 150 ft. and 440 ft. from the road, respectively, to a depth of 10 feet bgs. Ground cover consisted of an approximate 1-foot layer of moist tundra with sporadic dwarf shrubs. No groundwater was encountered. The soil profile at Site 10 can be generally described as:

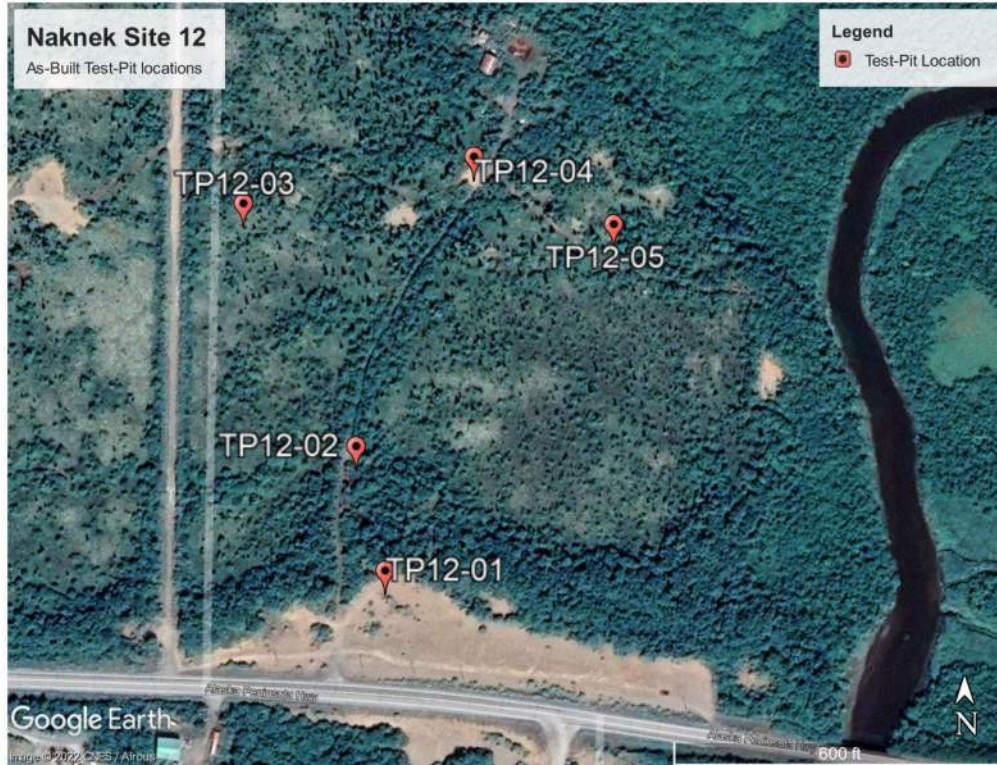
Figure A-4. Site 12 Aerial Map

Site 12 was located on Government Lot 4, roughly 500 ft. west of Paul's Creek. Five test pits were excavated at Site 12 (TP12-01 to -05) to a depth ranging from 9.5 to 19 feet bgs. TP12-04 was located on a commercial sand pit with the remaining four TPs located on highly vegetated land with high brush and tree groundcover. No groundwater was encountered at the site. The soil profile for site 12 can be generally described as:
